November 17, 2020

# 505 WEST CHAPEL HILL ST EXISTING BUILDING ANALYSIS

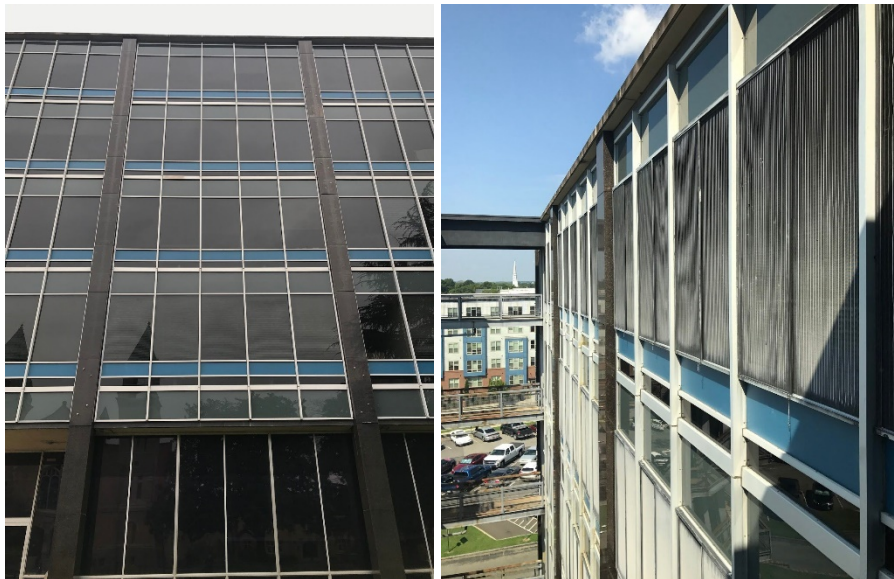
The building's curtain wall has a combination of tinted and annealed non-insulated glass with aluminum mullions for the second to fifth level curtain walls. None of the glass on the building meets current safety glass specifications. The ground level has a similar curtain wall system recessed from the building edge and supported by the floor slab. Sliding aluminum sunscreens over the curtain wall were replaced during the 1991 renovation and are mechanically fastened to the exterior mullion caps. Color fading has occurred from long-term exposure to sunlight, especially at the blue spandrel panels. The condition of the existing window film is poor. According to the Exterior Wall Evaluation Report, the building sealants have generally exceeded their useful service life and merit replacement. There is visible rusting of exposed fasteners that is causing streaks along the mullions. Additionally, the building's heating system is mechanically attached to the curtain wall framing. Removal of the mechanical system may reveal additional concerns.

North Facing Exterior Curtain Wall (Left) South Facing Sun Screens (Right)

Adding insulated and low-e glazing to the existing aluminum framing would require the entire assembly to be improved in order to meet current energy codes. The current enclosure has low comfort due to air leakage and poor thermal performance would be expected and is consistent with the findings of the existing exterior

wall evaluation report. The existing facade is far from meeting current energy conservation code requirements.

**Recommendation:** Full replacement of the existing curtain wall system will be necessary to meet recommended performance, human comfort and minimum safety precautions for the building. We recommend a thermally broken curtain wall with high performance low-e insulated glazing and safety glazing where required by code. Keeping the mullion pattern of the new system similar to the existing curtain wall would allow the facade to maintain visual continuity with the original design.

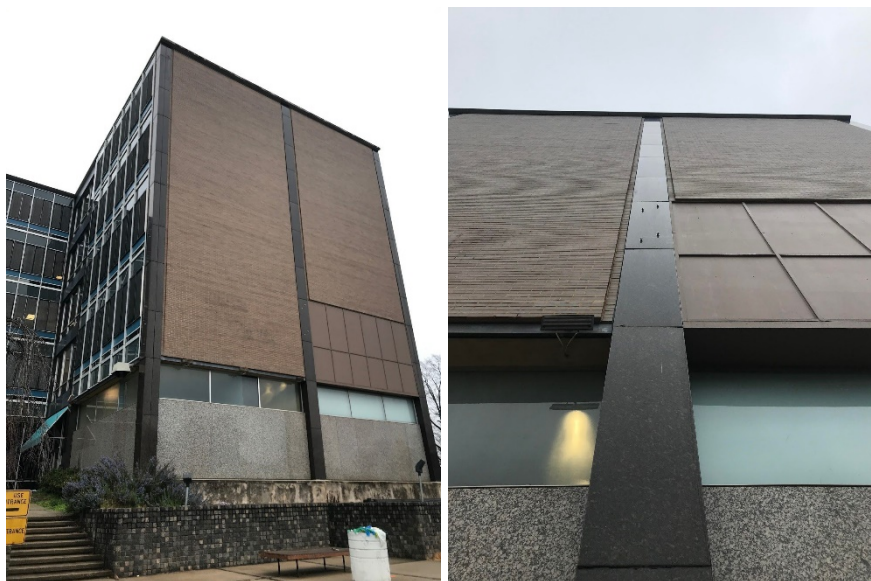
The existing double wythe brick wall on the east, west, and south facades were thoroughly examined in the Exterior Wall Evaluation Report, dated 5/31/2011. Continued deterioration of the brick shelf anchors has occurred since the report was originally written. Specifically, a major failure of the south brick facade and temporary repair with painted fiber cement panels. Additional brick failures will likely continue due to continued lack of moisture management and decision to not reinforce existing brick ledges as recommended in the report. Concerning building energy performance, the existing walls provide negligible thermal insulating value for the building as currently constructed.

Painted Fiber Cement Panels installed in bottom right-hand corner where brick failure occurred

**Recommendation:** Remove existing brick cavity wall due to continued failures. If the wall is determined to remain, additional brick ledge anchors as recommended in the Exterior Wall

Evaluation Report should be provided and replacement of ledges where necessary. Interior insulation (R-10 minimum) would be recommended on the interior to mitigate thermal transfer.

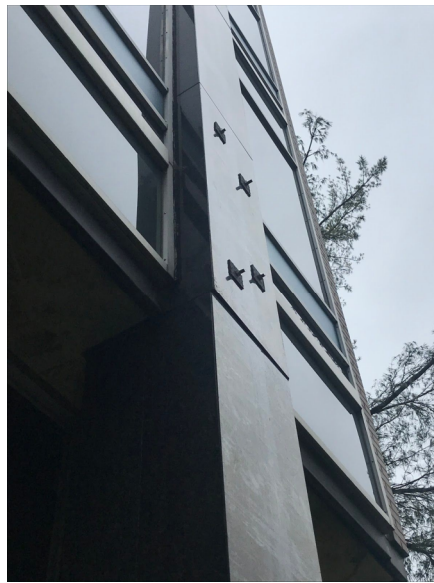
The exterior stone cladding on the columns is a manufactured product called Granux. Many of the panels show signs of temporary repairs using exposed through bolts to secure the panels to the structural columns as documented in the Exterior Wall Repairs as-built drawings, dated 6/24/2014. These repairs were recommended in the Exterior Wall Evaluation Report, dated 5/31/2011.

Previous Repair with Through-Bolt Fasteners

**Recommendation:** Remove granite cladding due to continued corrosion of shelf angle and attachment bolts, and visible temporary repairs. Replace with an alternate cladding material and properly secured to the building.

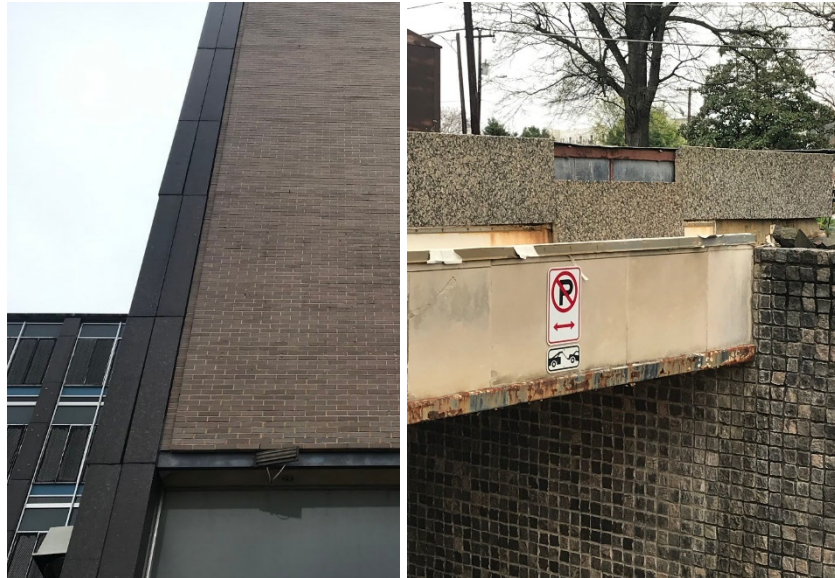
According to the report, the joint sealant material along the panel edges has well exceeded its service life and has left the joints vulnerable to water intrusion. Excess water accumulation inside the wall cavity has accelerated the corrosion activities of the support anchors, in particular, the shelf angles and attachment bolts. We observed the stone panels at the columns around the exterior and the open gaps and misalignment which is consistent with the previous building enclosure evaluation that represents the failing structural support.

Displaced Granite Cladding at Column and Loading Dock

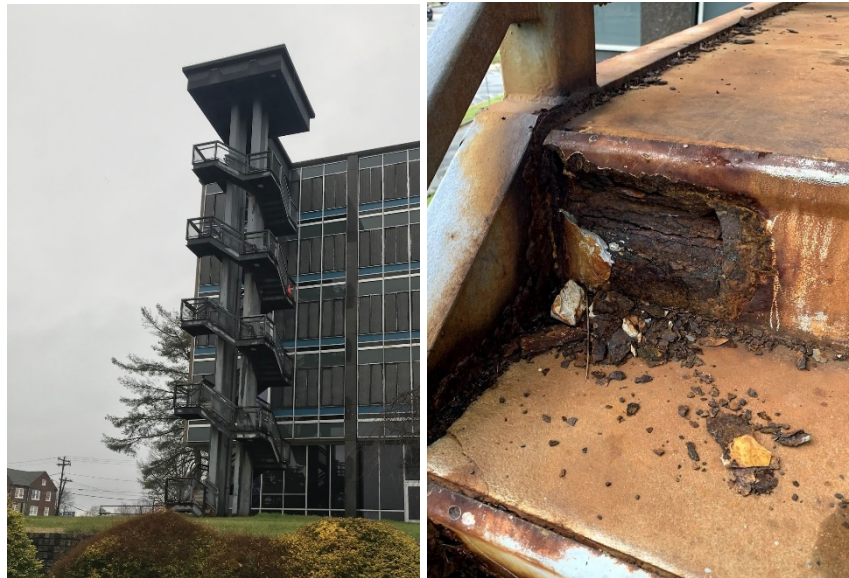
Stairway 3 is an exterior concrete-filled steel pan stair constructed in 1991 to serve as a second means of egress for Levels 2-5. The stairway currently does not meet current building code for maximum riser height, minimum riser run, or guard height. The stair has become unsafe due to exterior exposure to the elements and should be considered a hazard due to excessive corrosion of the metal pan, railing, and steel support framing.

Exterior Stairway Corrosion

**Recommendation:** This stair, including concrete footing and roof covering should be removed and replaced with a new enclosed stairway to serve Levels 2-5 as the second required means of egress. The reconstructed stairway should also be designed to access the basement level and provide a code required second means of egress allowing flexibility and full utilization of the space. See Interior Axon Diagram.

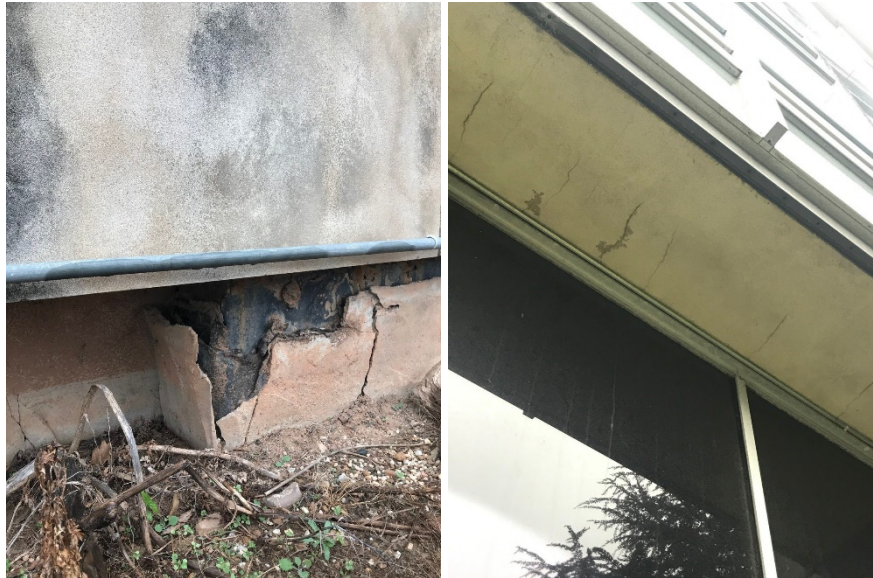
The existing lathe and plaster soffits, column wraps and base finish are showing damage from water intrusion and subsequent corrosion of the metal lathe.

Lathe and Plaster Failure at Base (Left) and Soffit (Right)

**Recommendation:** Replace existing lathe and plaster surfaces with alternate material where appropriate.

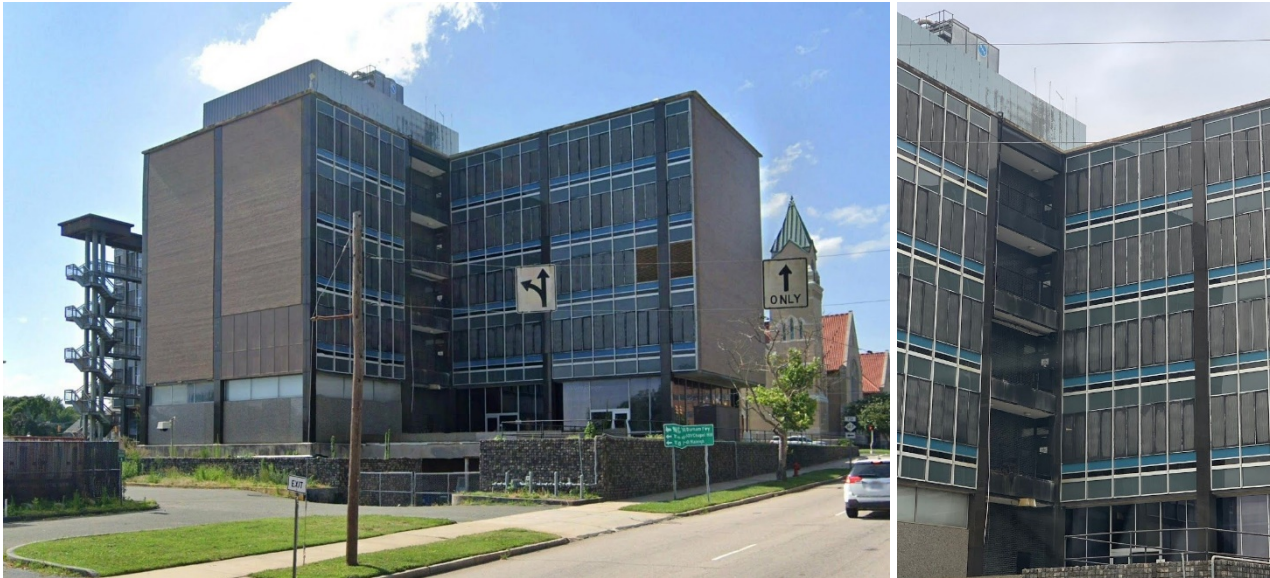
Stairway 1 is accessed from the building interior by an exterior balcony on the east facade. Repairs were made in 2014 to the balcony railing at Levels 2-5 due to significant corrosion and life safety concerns. However, the repair was not a permanent solution to the damage being caused by continued exposure of the steel components to moisture. Further investigation is needed to determine the structural integrity.

Google Earth Street View from Duke Street (Left), Exterior Balconies

**Recommendation:** Remove balcony guardrails and infill existing Stairway 1 and balcony in order to add additional leasable space. See Interior and Exterior Axon diagram.

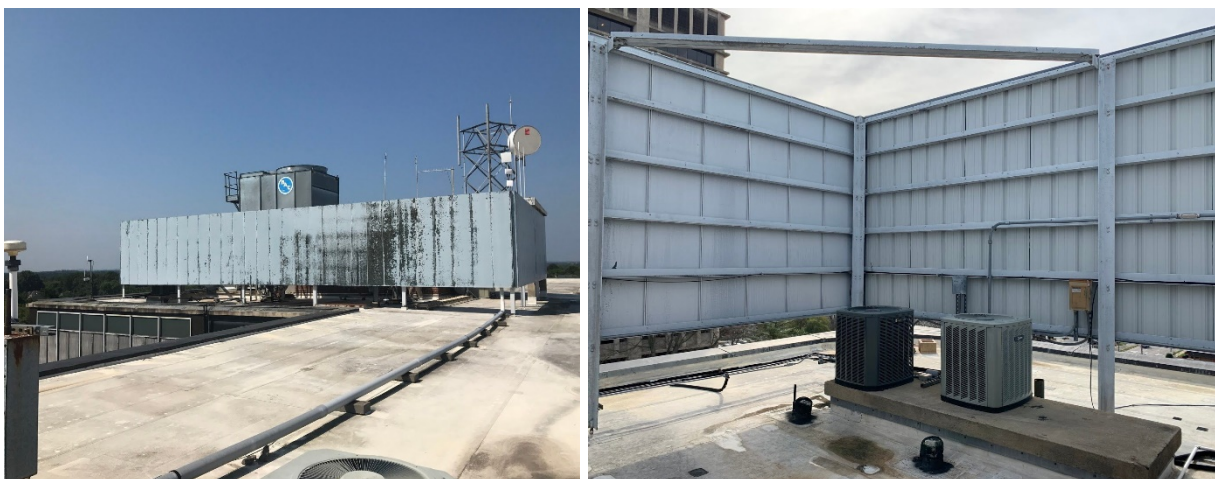
The mechanical screen wall appears to be in fair condition. It has a large operable sliding door on the west facade. Peeling and fading of the existing panels is extensive, however the integrity of the steel framing appears to be in good condition. The screenwall currently does not fully conceal the cooling tower.

Exterior and Interior of Mechanical Screen Wall

**Recommendation:** Reclad existing screen wall cladding. Remove the communication tower and equipment. Depending on the size, position and height of the new equipment, cladding will be configured to screen all equipment.

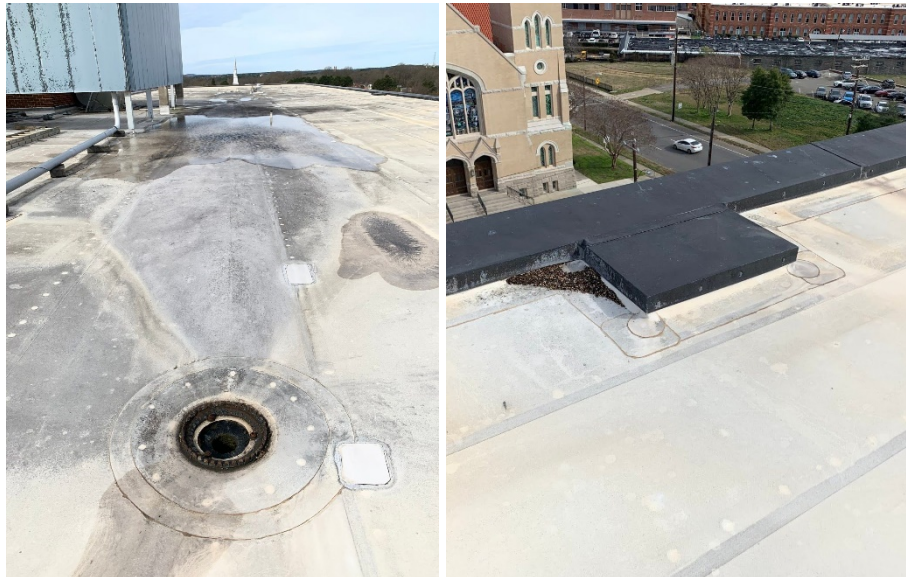
The existing single-ply membrane roof is showing considerable wear with a large amount of patching. Several areas of ponding due to lack of code minimum slope is apparent. The condition of the roof insulation is unknown, but soft areas of the roof were observed which may indicate water absorption due to leaks. Current perimeter parapet design is approximately 3" above the height of the roof surface making the addition of increased insulation challenging without replacement of perimeter coping.

Ponding of existing low slope roof and 3 inch perimeter coping.

**Recommendation:** Replace existing roof with new roof assembly providing  $\frac{1}{4}$ " slope with 20 year warranty, minimum. Replace perimeter coping.

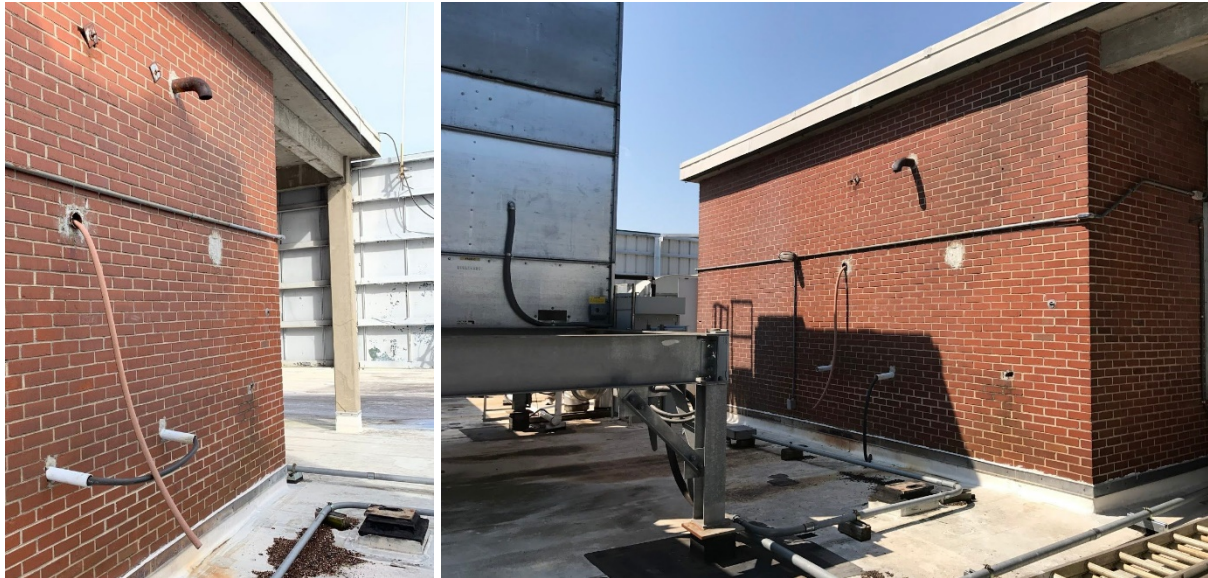
The penthouse includes a reinforced concrete frame that appears to be in fair to good condition. The existing brick walls have several holes and/or penetrations that are either open or have not been properly sealed. Numerous, minor spalls were found along the surface of the concrete ceiling, and these may be due to previous hanger attachments.

Unsealed openings and penetrations in masonry.

**Recommendation:** Repair holes in existing brick walls and seal penetrations to increase water tightness.

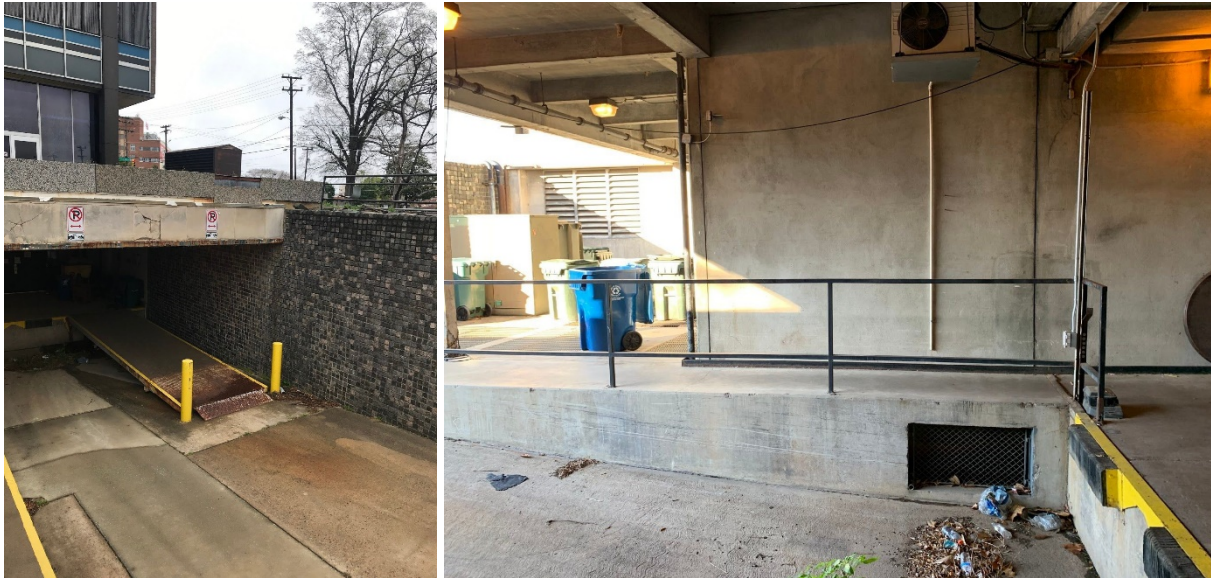
The loading dock has two bays and a 48 inch high dock for unloading. Access to a grate covered area way and transformer pad are accessed through the loading dock. The dock is partially covered by a terrace area above. A planter box bordering the south edge of the terrace acting as a guardrail. Several granite panels at the planter box were found to be loose or displaced. Two exterior steel columns provide support for the overhead framing for the terrace. These are encapsulated by metal lathe and plaster that has been severely damaged from impact and the long-term corrosion of the lathe. There is also moderate corrosion of the tube steel. The plaster and lathe should be removed from the columns to allow them to be cleaned of rust for further inspection.

Loading Dock with Terrace

**Recommendation:** Refer to structural analysis for comments on the condition of the terrace structure. Repairs to the terrace planter box are required for safety purposes. Further drainage analysis will be required to limit flooding of sub-basement.

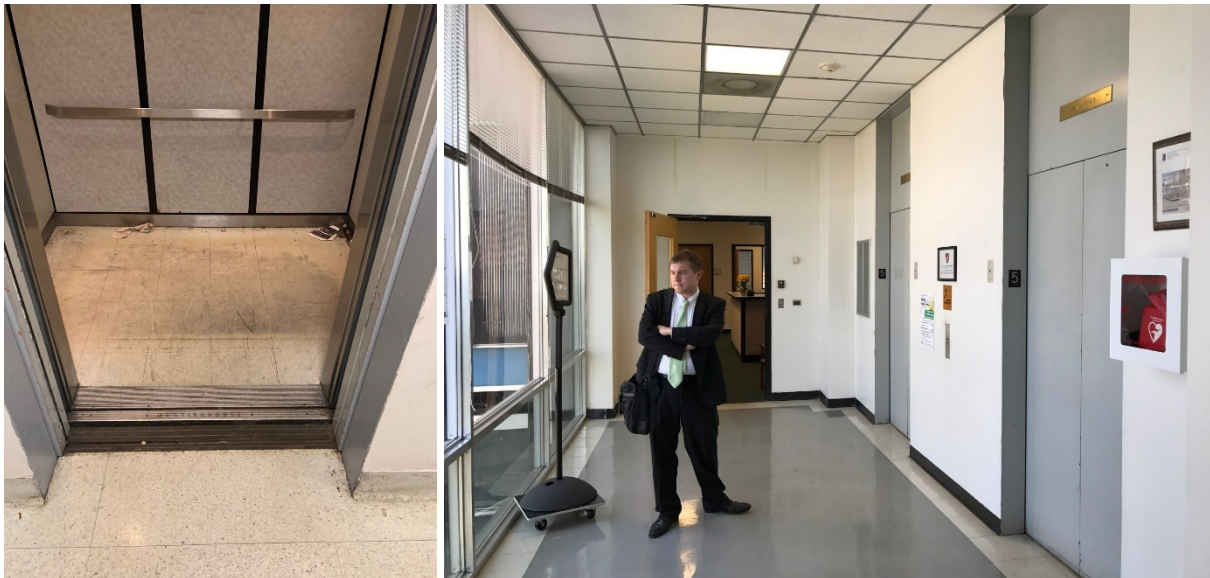
The building contains two center opening 3,000 lbs traction elevators that serve Basement through Level 5. The elevator pit is located within the sub-basement level. The traction elevators are rated at 300 fpm which will provide a high level of service for future office levels. The elevator cabs and machines are original Westinghouse and the current control panel is Schindler, which was installed in 2011 according to maintenance records. Since the building is not a high-rise, the existing building code does not require the elevators to meet current building code requirements. If replaced, new elevators would be required by the building code to meet accessible means of egress requirements, accommodate an ambulance stretcher, and be connected to standby power. Two-way voice communication at each elevator lobby would also be required.

Existing Elevator Interior (Left) and Lobby (Right)

**Recommendation:** Refinish existing elevator entrances and cab surfaces. Future replacement would need to be considered given the age of the existing elevators.

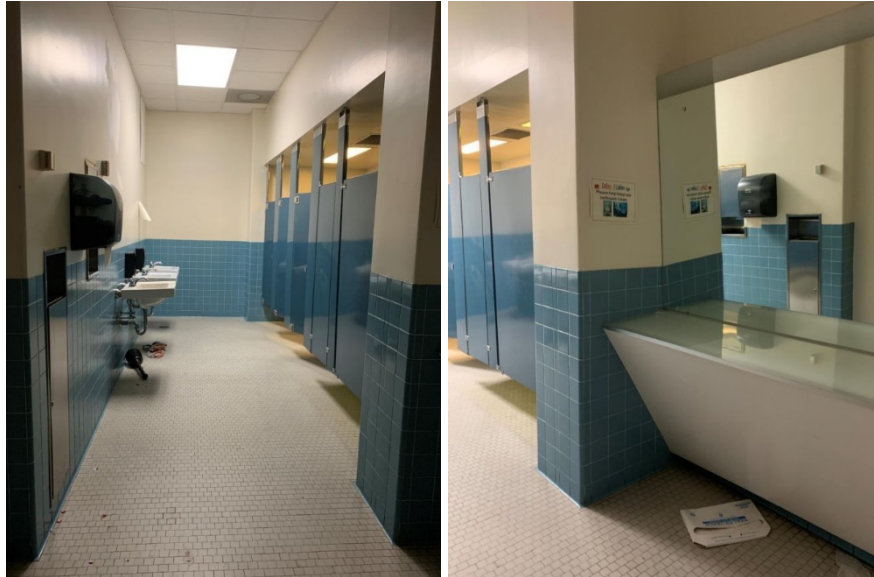
The typical floor restrooms are adequately sized in order to accommodate expected plumbing fixtures. The toilet partition layout will need to be revised to accommodate ADA accessibility requirements and new partitions installed. We recommend replacing the floor, wall, and ceiling finishes.

Typical Restroom

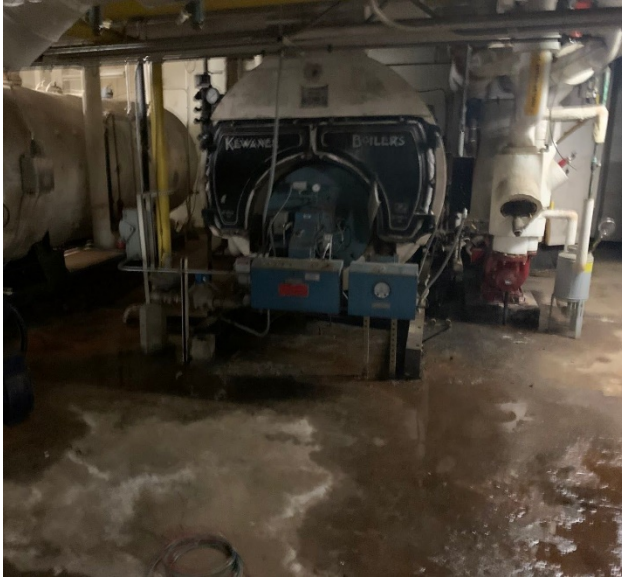
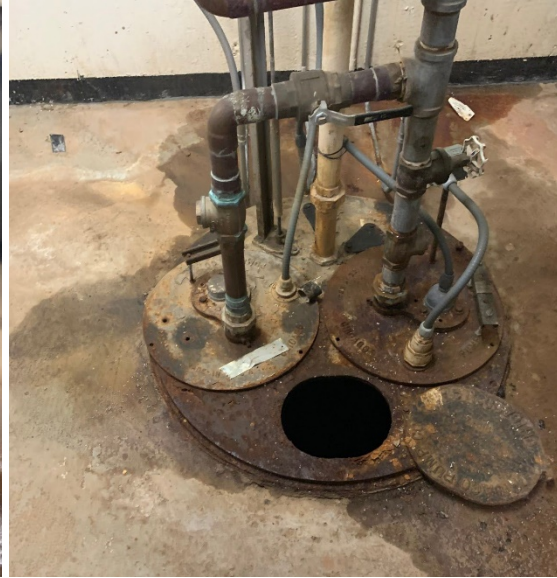
The building's sub-basement is currently damp and has visible ponding. According to the Exterior Wall Evaluation Report, dated 5/31/2011, the basement has had previous flooding issues that caused mechanical equipment damage. The flooding appeared to have entered the sub-basement through the loading dock and adjacent mechanical areaway. Several pieces of equipment in the sub-basement show corrosion damage.

Sub-basement Moisture Issues

**Recommendation:** Provide crystalline waterproofing coating to the inside face of existing basement walls where needed. Maintain or replace sub-basement sump pit and loading dock drains to minimize water intrusion. Surface drainage should be confirmed with the Civil Engineer and Landscape Architect to ensure water is diverted away from the building.

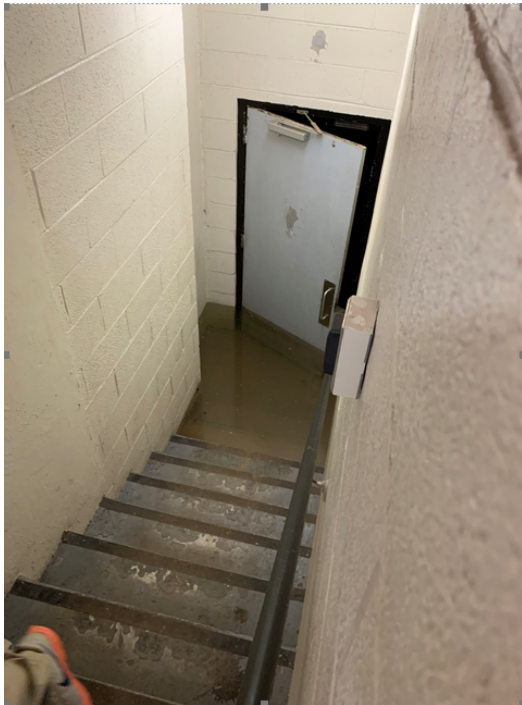
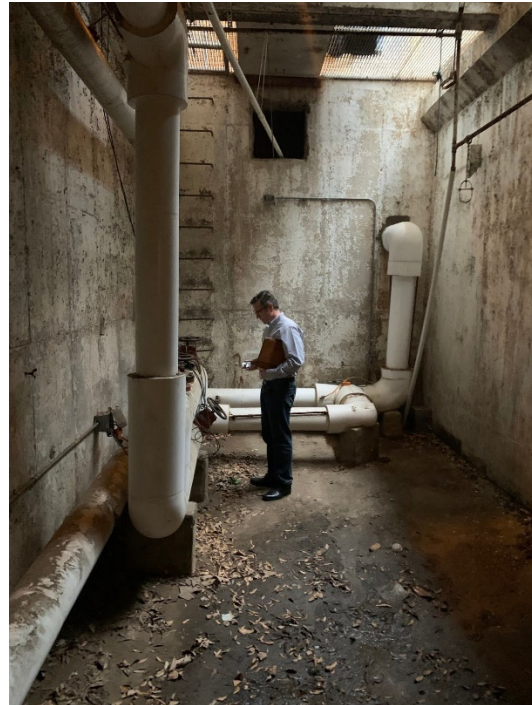
Open Areaaway at Sub-basement Level

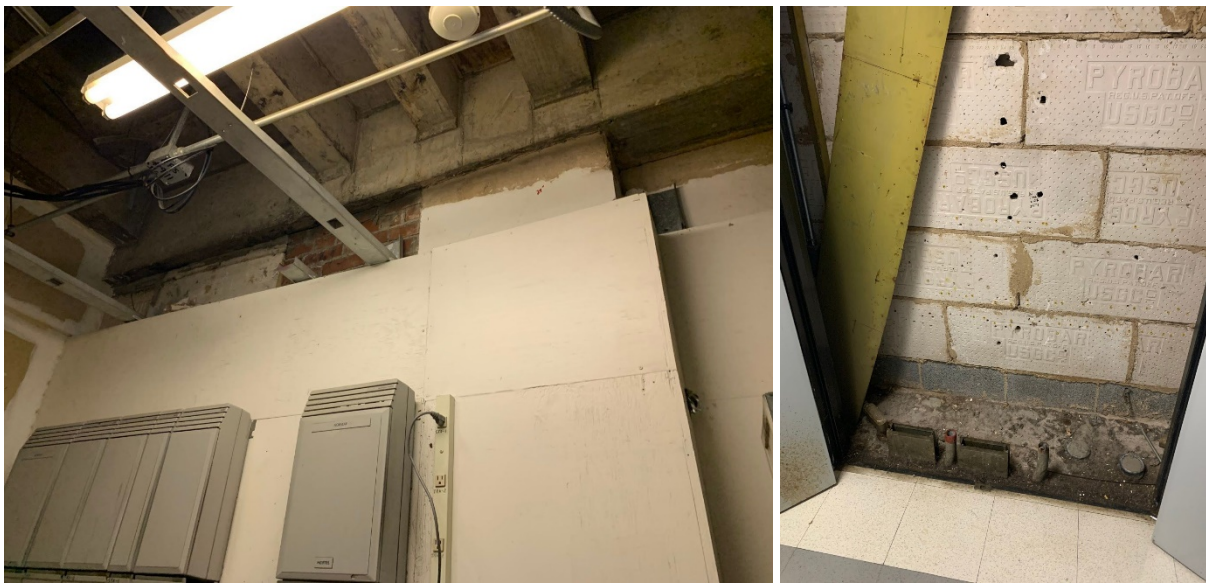
Interior partitions were originally constructed from gypsum block or clay brick. Later remodels used metal stud partitions. Due to their location in the building most of the metal stud partitions separating existing offices will be removed from future open areas during demolition. A high percentage of the core area walls are original, such as mechanical shaft walls, stairway enclosures, and elevator shaft walls. These walls will be more difficult to add new electrical, plumbing and low voltage systems to because of their solid construction. Damage and holes in existing fire rated walls has been observed.

Varied partition construction (left) and damaged USG Pyrobar gypsum elevator shaftwall (right).

**Recommendation:** Removal of all interior partitions except rated shaft walls and stair enclosures in order to provide a shell and core condition for leasing. Careful coordination of electrical and plumbing routes will need to be reviewed where solid gypsum or masonry walls are to remain. Plaster repair will be required at new and existing penetrations and joints. Firestopping holes, joints, and pipe penetrations will be required in existing fire rated partitions.

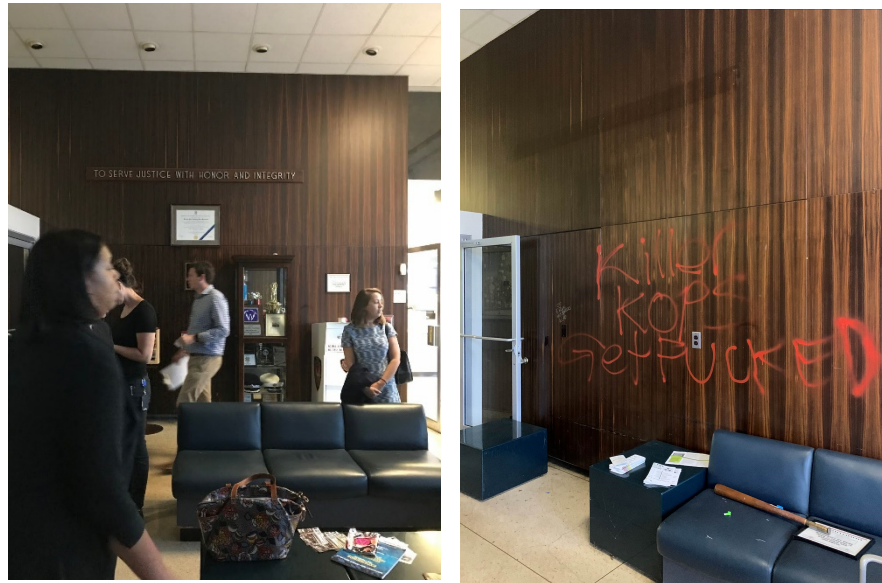
The lobby has a striking marble clad elevator accent wall. It appears to be in good condition. Wood accent paneling in the lobby may be able to be repurposed but was further damaged along with other building features during protests this Fall.

Main Lobby wood wall panel damage from Fall 2020 protests (right)

**Recommendation:** Repair cracks and clean terrazzo where possible to remain. Repurpose original wood paneling and interior stone cladding where possible.
